I. STRUCTURAL SYSTEMS

A. Foundations (If all crawl space areas are not inspected, provide an explanation.)

Type of foundation: Slab-on grade

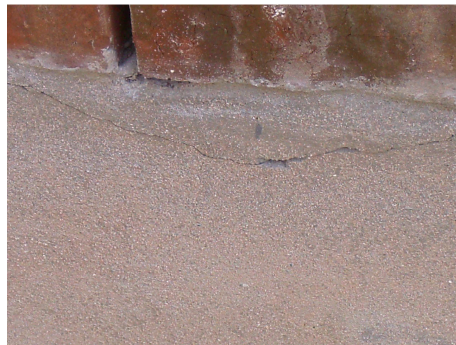
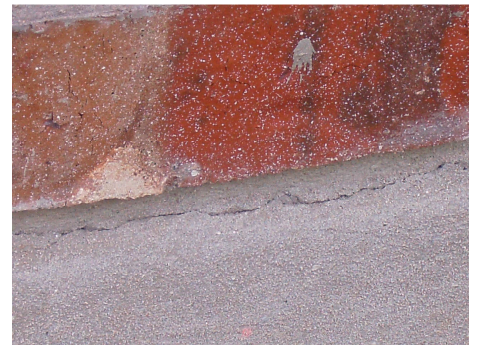
Common minor cracks were observed in the foundation walls of the home along the south side of the house. This implies that some structural movement of the Home has occurred, as is typical of most homes.

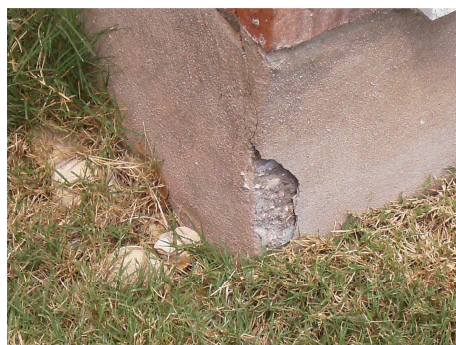
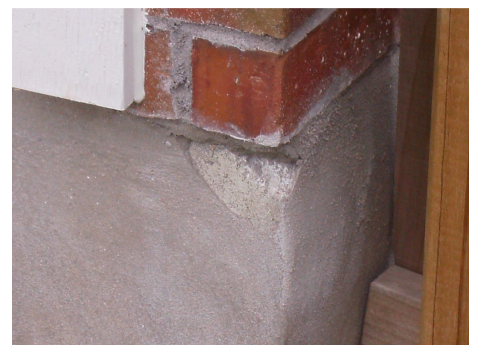
Surface deterioration (known as spalling) was observed on the exterior of the exposed foundation walls at the north east and northwest corner of the house. This condition is common in many homes and does not usually represent a structural concern. In an effort to prevent long term deterioration, it would be wise to consider parging deteriorated areas. Lot drainage improvements, as outlined in the "Exterior" section of this report are also recommended. Recommend repair by licensed contractor.
